Volume 8

Asbestos-Containing Material Re-inspection For Building 36 Charleston Naval Shipyard Charleston, South Carolina

Contract No. N2467-96-D-0998 Delivery Order No. 0013

BAT Associates, Inc. 5151 Brook Hollow Parkway Suite 250 Norcross, Georgia 30071 (770) 242-3908

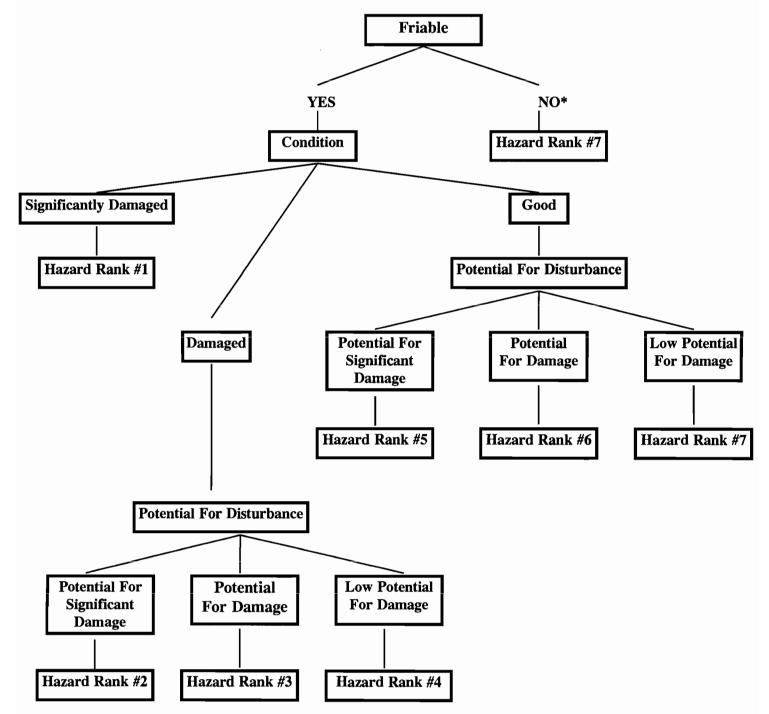
Figure 1.0 Decision Tree Diagram For Hazard Assessment

Hazard rank #1 are materials of highest concern, and hazard rank #7 are the materials least likely to release asbestos fibers to the work area.

^{*}Miscellaneous materials that are considered non-friable were placed in the Hazard Rank #8 category, which is in good condition with a low potential for damage.

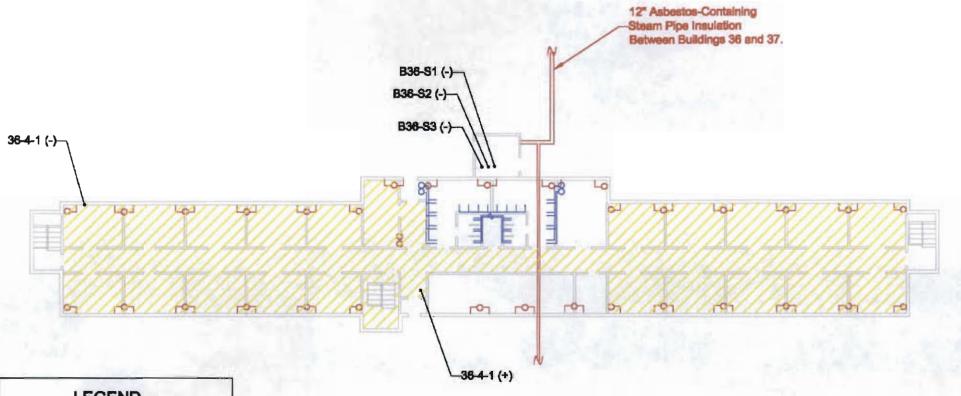
- Sample Location
- (-) Non-Asbestos-Containing Sample Location
- (+) Asbestos-Containing Sample Location
- Asbestoe-Containing Floor Tile and Mastic
- Pipe Fitting Insulation on Riser and Branches to Radiator
- Asbestos-Containing
 Pipe Fitting Insulation
 on Domestic Water
 (Inaccessible in Walls)
